Cantilevers

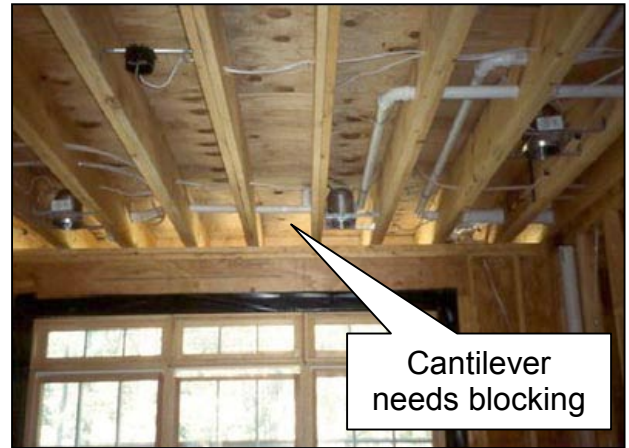
As can be seen in pictures two, five and six blocking is missing between each floor joist. Picture four cannot be blocked and will require the cantilever bottom sheathing to be installed airtight. This can be accomplished by applying caulk or foam. If it is not sealed, air will pass through the insulation and into the house through the floor system.

The truss company will design an upright solid piece of wood at the point where blocking is needed if specified during the design phase.

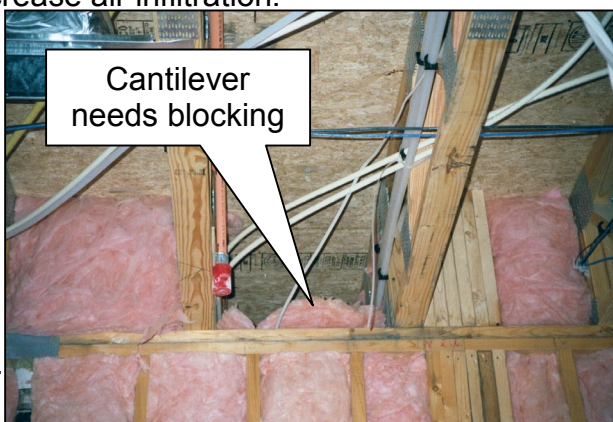
Insulation is the only barrier in pictures 5 and 6. A rigid barrier, such as oriented strand board (OSB), plywood, or Thermoply™, should be installed. This protects the insulation from wind intrusion and will decrease air infiltration.
