Pinched Batts

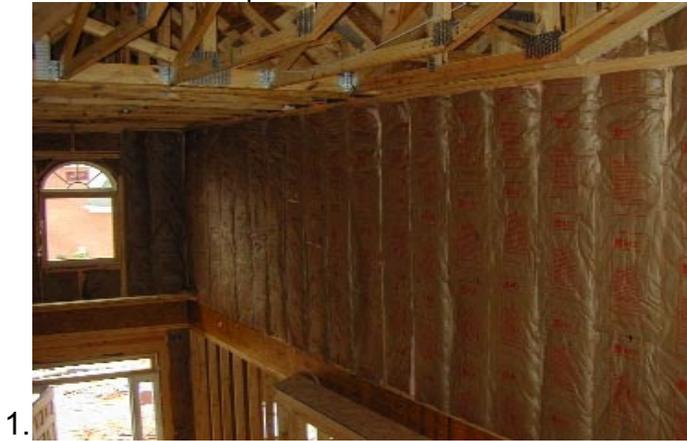
1.

Picture one shows a wall that appears to be a very fine job. Pictures two through four are the back-side of this wall. As you can see the insulation is pinched.

Care should be taken when face-stapling kraft-faced batts. The effective R-value of the insulation can be *significantly* reduced if the installer does not ensure 1.) the batt is filling the entire stud bay cavity and 2.) the insulation is not pinched between the face of the stud and the paper flange.

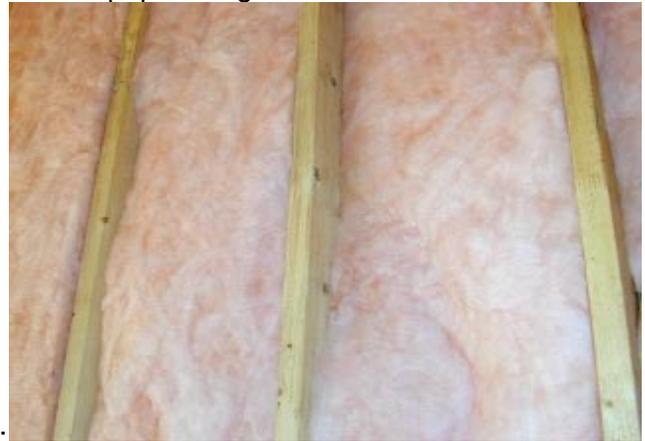
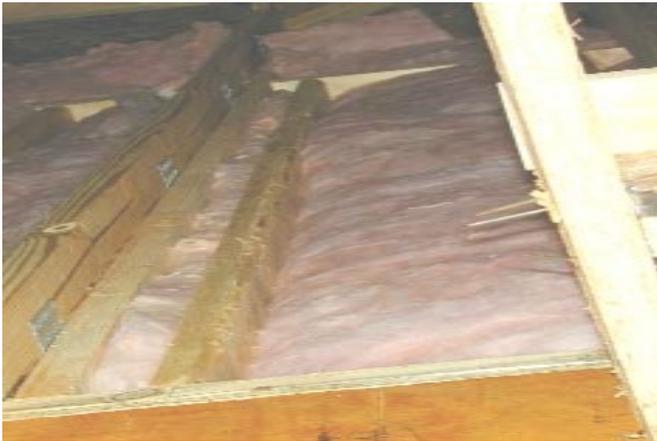
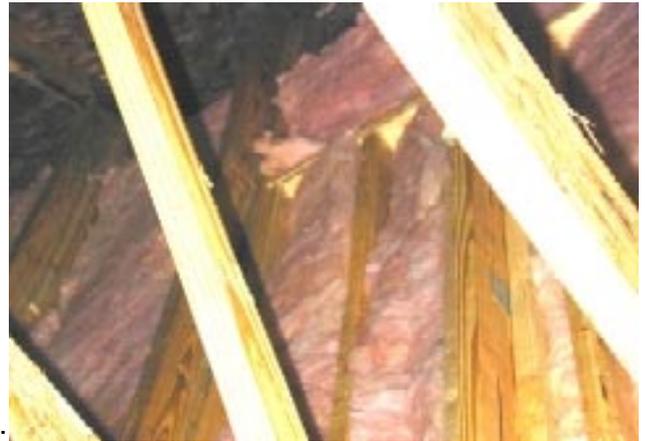
The paper on the batt has been pulled back in pictures five and six to show how the insulation can be pinched between the paper flange and the stud. This avoidable mistake can be seen in pictures two through four.
